Mundell, C, McCombie, PF, Heath, A, Harkness, J & Walker, P 2010, 'Behaviour of drystone retaining structures', *Proceedings of the Institution of Civil Engineers-Structures and Buildings*, vol. 163, no. 1, pp. 3-12. <https://doi.org/10.1680/stbu.2009.163.1.3>

Behaviour of drystone retaining structures

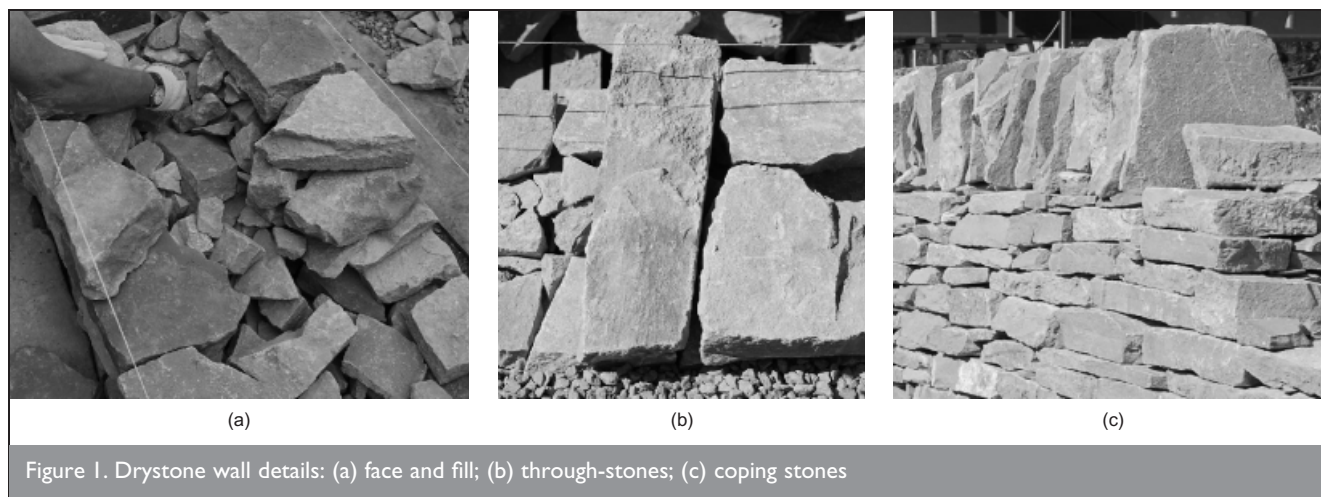
Although many differences exist between the various drystone construction styles, several common features are usually exhibited. Typical drystone walls are built in horizontal layers or 'courses' with each course ideally consisting of stones of a uniform thickness, thus presenting a straight and level appearance. The cross-section of the wall usually consists of a tightly packed outer face with a core of smaller blocks and fill packed behind (Figure 1(a)). Some drystone retaining walls follow this core material directly with the retained backfill material, while others have a second inner face, usually less well finished than the outer face. 'Through-stones' span from the outer to the inner face, binding the wall together (Figure 1(b)). Where there is no inner face, through-stones are often used to anchor the outer face further back into the packing fill. Coping stones can act in a similar manner, spanning the entire width of the wall at the crest (Figure 1(c)).

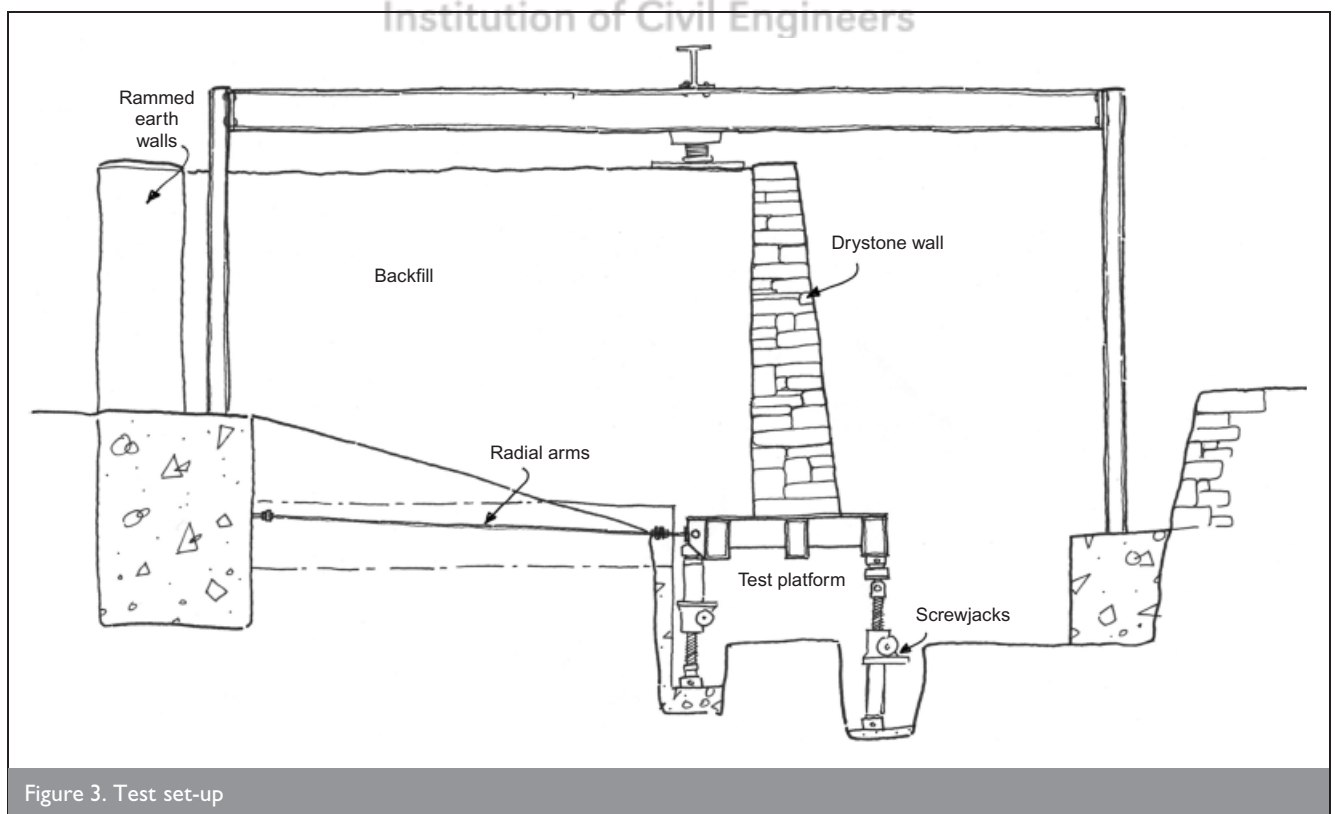
Figure 3. Test set-up

Each of the tests described in this paper was carried out consecutively in a unique outdoor test laboratory. As mentioned earlier, to avoid the issue of end effects, each wall was required to have a significant length/height ratio; 12 m wall lengths were chosen, with a height of 2.5 m through the central test area (this includes coping stones that constituted

the top 300 mm). The central 4 m of each wall rests on an articulated platform, supported by four screwjacks, with the ability to move vertically as well as tilt forwards or backwards. This allows both foundation and backfill settlement to be imitated, with movements being directed from a remote

control station at a rate of up to 10 mm/min. In addition, a steel frame was erected over the central portion of each wall, from which a 200 kN capacity hydraulic jack was suspended, allowing a localised surcharge to be applied through a loading plate onto the backfill (Figure 3).

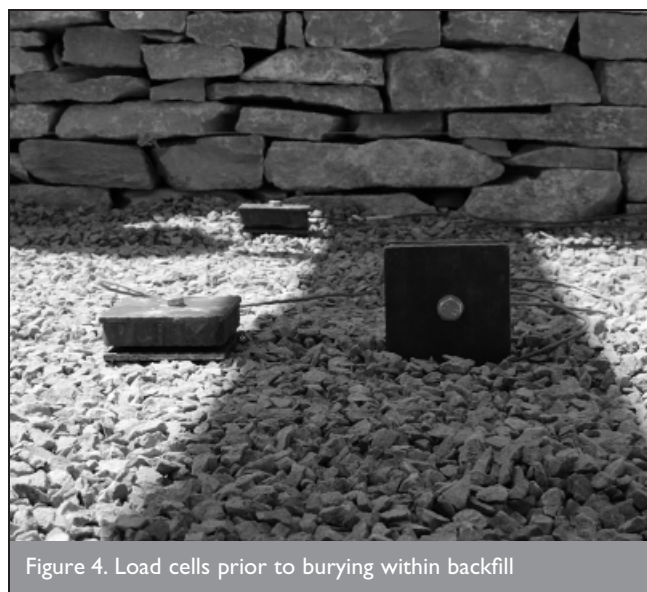
Figure 4. Load cells prior to burying within backfill

As previously mentioned, load cells attached to the platform monitor the overall forces being applied to the wall. The first two tests augmented this information by using small load cells within the backfill. These load cells were sandwiched between 100 mm × 100 mm steel plates and placed at critical locations within the backfill, orientated to record either horizontal or vertical pressures (Figure 4). The aim was to use these data to help determine the distribution of stress within the gravel arising from the surcharge loading. This form of monitoring was discontinued after the second test wall as the results were often inconsistent and erratic, mainly due to the small scale of the steel plates in relation to the size of the gravel. Larger plates were considered, which would give more reliable readings, but these would have a greater impact on the test itself and possibly affect wall behaviour.

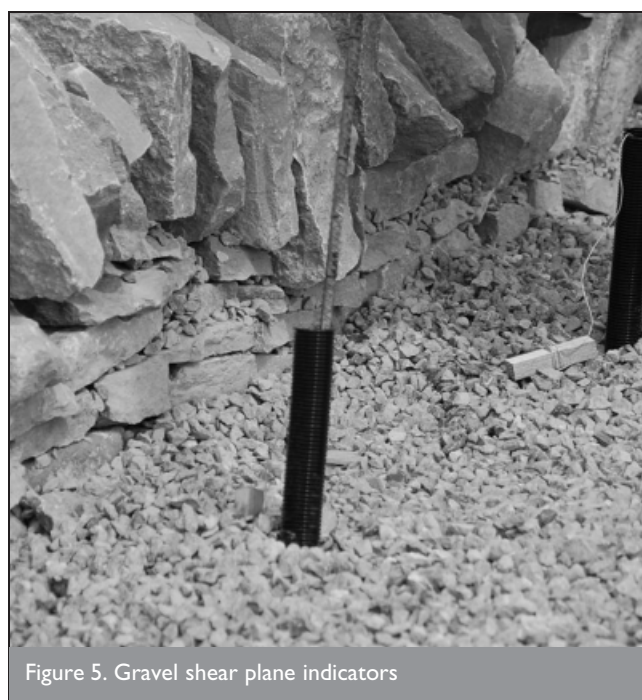
Figure 5. Gravel shear plane indicators

moves during testing, and in particular where failure planes develop. Two methods were used to assess this, beginning with the placement of ball bearings within the gravel. Each ball bearing was numbered and its position determined using a total station. Upon destruction of each wall, the gravel was carefully unearthed and the ball bearings located using a metal detector. Using the total station to determine their final positions, the overall movements of the ball bearings were calculated and from these data the location of the gravel's failure plane found.

For the third and fourth walls, the ball bearings were replaced with long, very flexible plastic tubes placed vertically into the gravel using a mandrel. Throughout the tests, long marker poles were lowered down the flexible tubes until either the end or an obstruction (such as kinks caused by developing shear planes) occurred (Figure 5). With similar data obtained from several locations, this method identifies the failure plane quickly and easily during the test and so was adopted in favour of the time-consuming ball bearing approach.

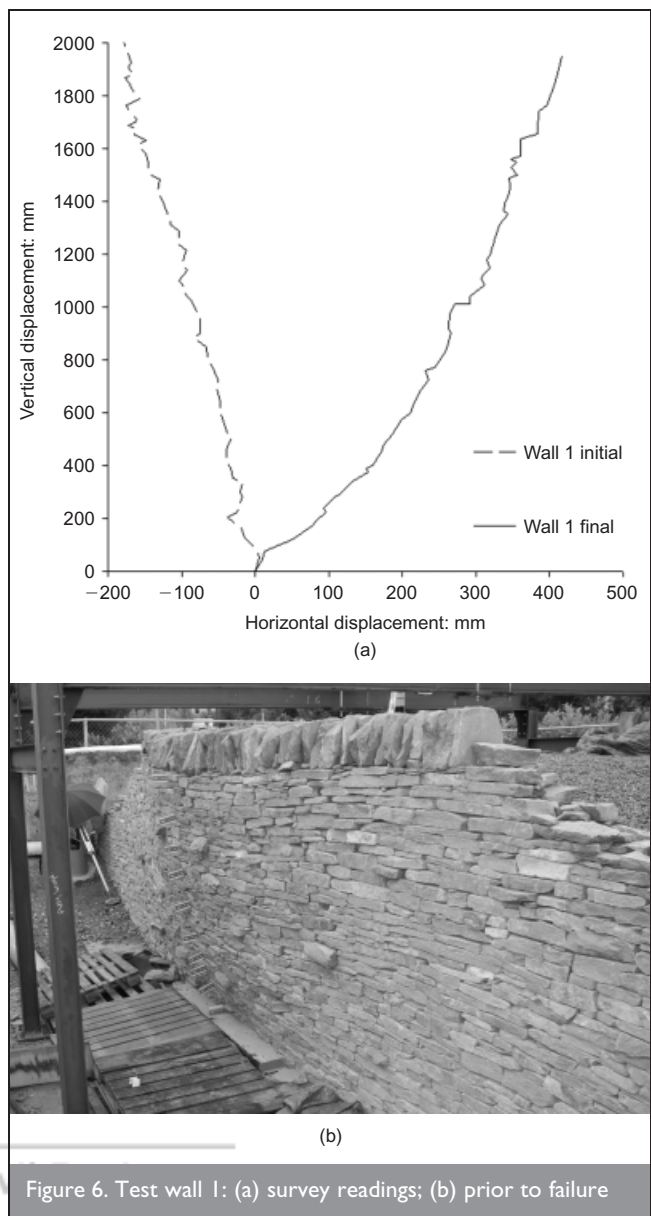
Testing of this wall (Figure 6(a)) was carried out a month after construction in July 2007. The wall was regularly monitored using the surveying equipment to identify any settlement or deformation in this period. Backfilling took place in tandem with wall construction, ensuring that the fill height was approximately 0.5–1.0 m below the wall height, allowing a comfortable working position for the masons. The fill was introduced in layers of 300 mm and compacted with a 1 kN vibrating plate compactor until the full height of 2.2 m was achieved, leaving the top 300 mm of coping stones uncovered. Plate loading tests on the gravel indicated an initial angle of friction of 50.1° . As this is likely to be significantly higher than generally found behind walls of this nature, this issue was addressed for subsequent walls. The voidage of the wall was approximately 28%.

Prior to failure, the wall had substantially deformed, having moved forwards over 650 mm at the crest, overhanging the wall toe by some 500 mm (Figure 6(b)). Although there was evidence of bulging within the structure, the primary failure mechanism was toppling, encouraged by both the rotation and the initial surcharge location.

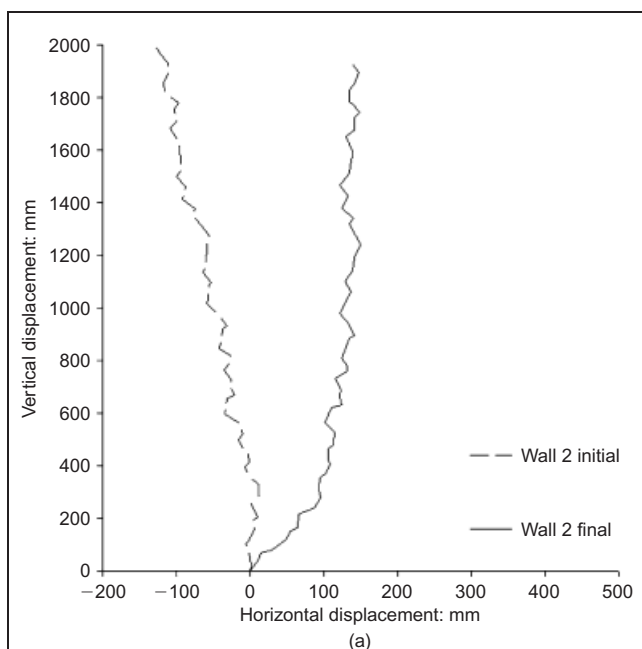
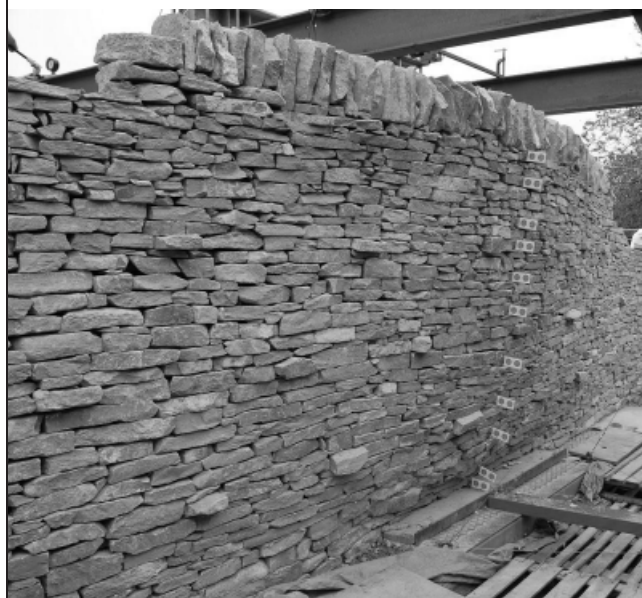
Figure 8. Test wall 2: (a) survey readings; (b) prior to failure

Final deformations were less severe than in test wall 1; the coping moved 300 mm in total, with some 250 mm overhang over the toe (Figure 8). The manner of movement was also much closer to the mechanisms found in many existing retaining walls. Instead of monolithic toppling of the first wall, the second wall displacements were non-linear with respect to vertical height. For example, an hour prior to failure an overhang of 100 mm was measured at a third-height of the wall, followed above by a gradual reduction in overhang, ending with the coping stones being 50 mm in front of the toe line.

Although test wall 2 also eventually failed by toppling, the manner in which this toppling was achieved was different to that of the first test wall. In this instance, it was found that the lower blocks of the wall were sliding over one another,

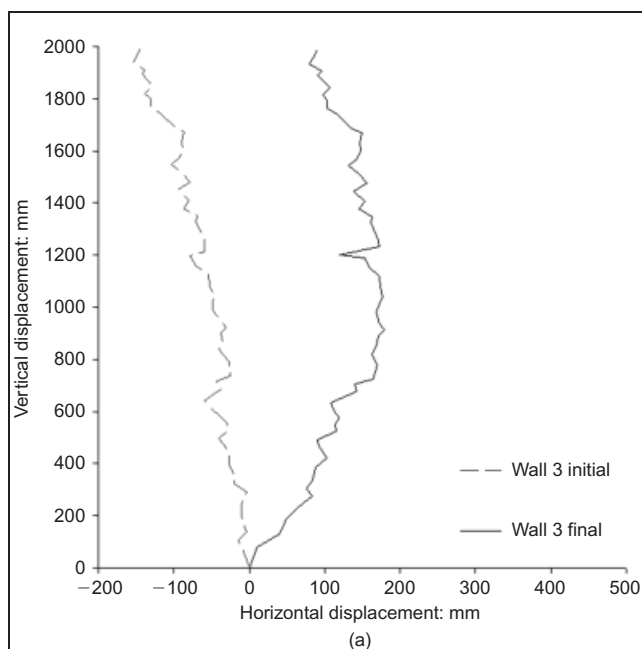
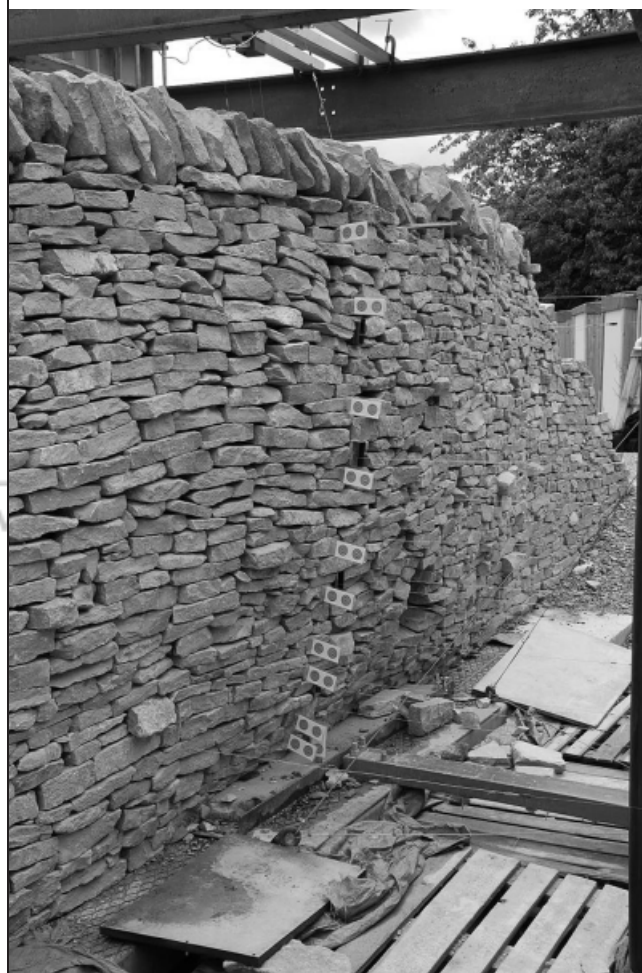
Figure 9. Test wall 3: (a) survey readings; (b) prior to failure

After the initial platform movements, the applied loads to the structure caused definite bulging to occur within the wall. Monitoring of the flexible tubes within the backfill indicated that the failure wedge was developing at a relatively shallow angle, beginning directly behind the surcharging plate and terminating at the face of the wall some 500 mm above the toe. As a consequence, the bulge's centre was slightly higher than that produced in test wall 2, occurring roughly 1 m above the base and overhanging the toe by over 350 mm before failure (Figure 9). The extremely pronounced nature of this bulge, combined with the large internal void spaces due to the roughness of construction, caused significant cracks to open along the face of the wall. In addition, large amounts of material were able to drop both through internal voids within the wall and out of the wall face itself (Figure 10(a)).

Eventual failure was again because of bulging, driven by the continuous displacement of the backfill. However, there was also a visible bursting at various sections during the failure, as the areas below the main bulges were unable to resist the horizontal forces of the sections above (Figure 10(b)). As a result, a large amount of material slipped forwards rather than toppling from the toe as failure progressed.

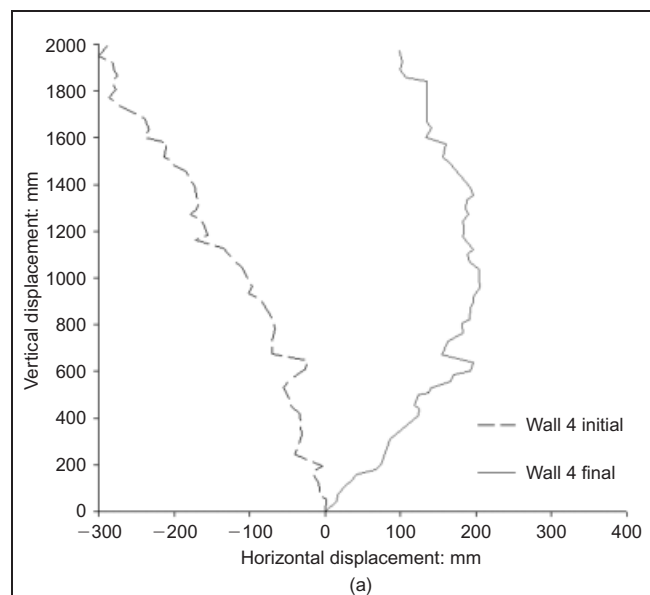
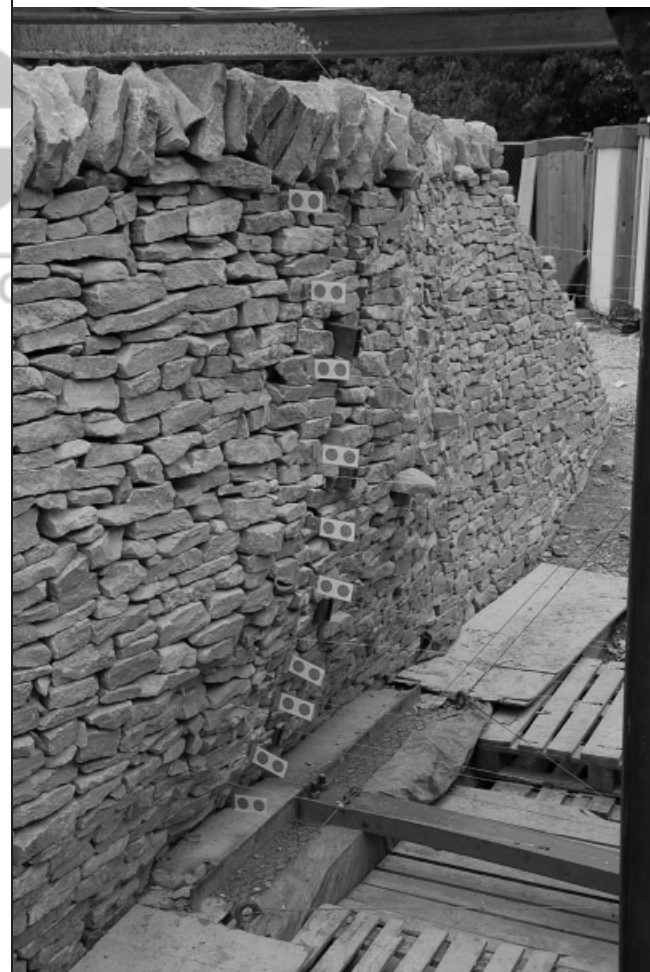
Figure 11. Test wall 4: (a) survey readings; (b) prior to failure

Maximum displacements, while remaining stable, were slightly lower than those in test wall 3, bulging outwards some 200 mm

at a vertical height of 1.1 m from the toe (Figure 11). However, the crest of the wall moved a comparatively smaller amount, giving a more visually obvious bulge. From the fixed mount camera images, it is also apparent that this wall contained a higher number of running joints with large vertical cracks opening approximately every 500 mm along the face of the wall. Collapse initially began over the central 4 m of wall as a

— Wall 4 initial
— Wall 4 final
